VULNERABILITY OF SPACE STATION FREEDOM MODULES-
A Study of the Effects of Module Perforation on Crew &
Equipment

Volume I - Experimental Program

By : J. Serrano, D. Gala, D.J. Liquornik & R. A. Hayami
University of Alabama in Huntsville
and
Joel Williamsen,
Structural Development Branch
NASA, Marshall Space Flight Center
Huntsville AL

Final Report, Vol. I: Contract NCC8-28
Period 09 September 1993 - 14 March 1995

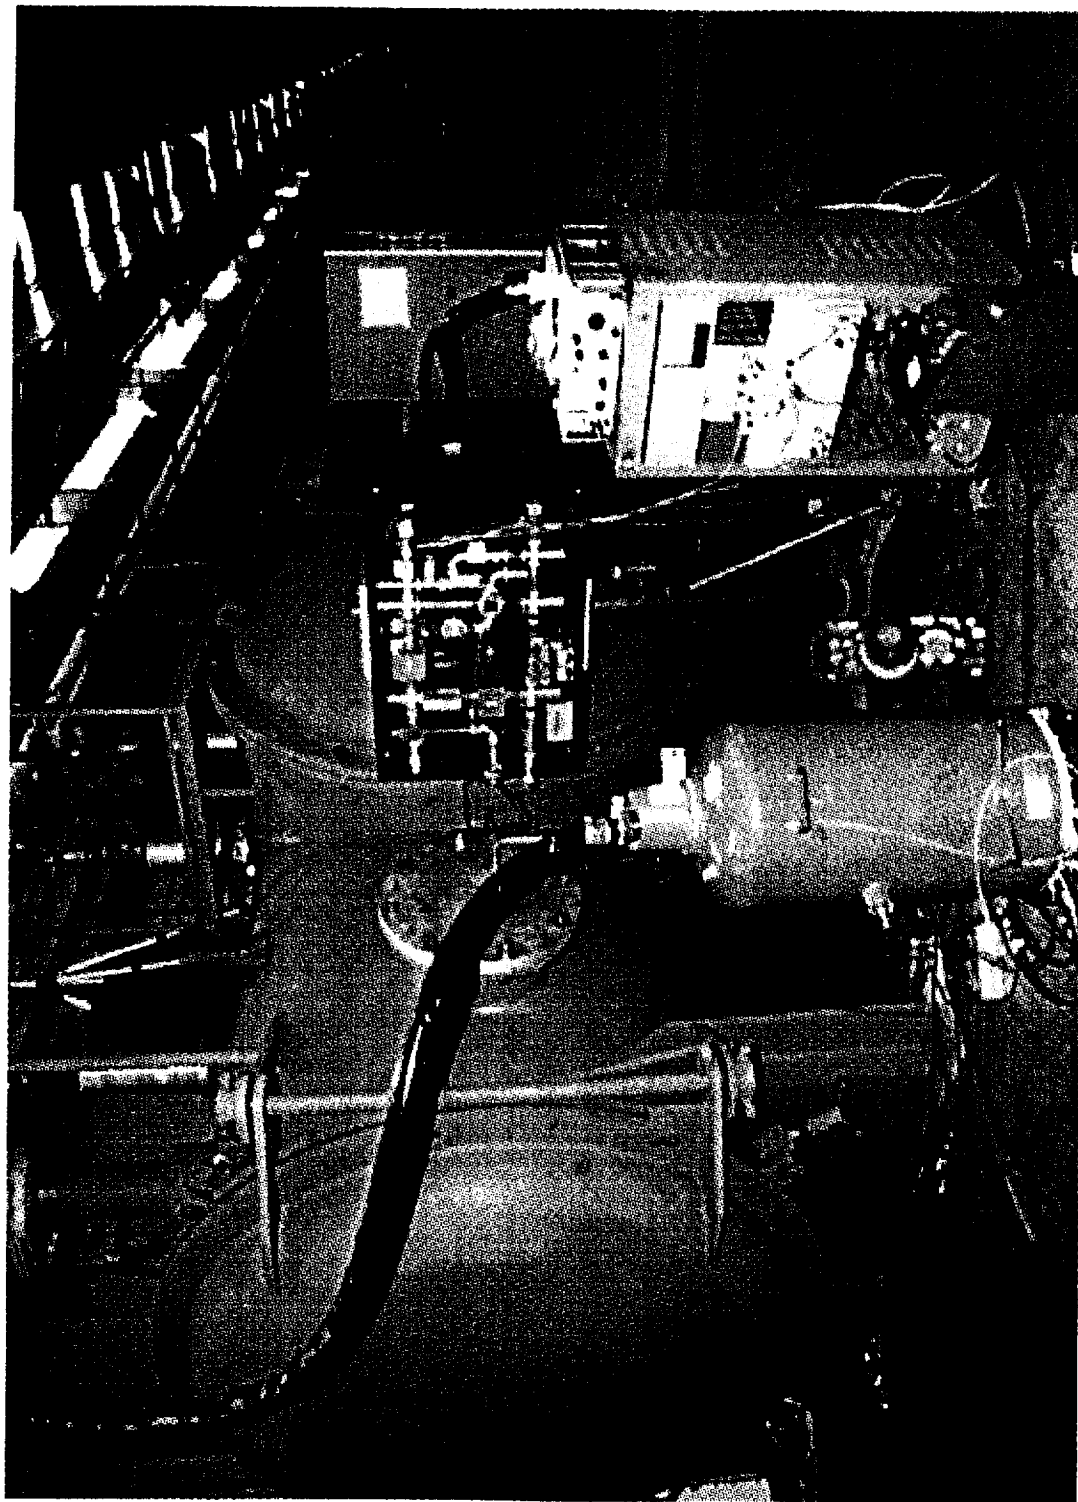
Figure 1 shows a photograph of the external view of the target chamber looking at the chamber from the North West side. The pulser for the flash X-ray and the 17 GHz Doppler radar can be seen in the foreground. Figure 2 shows a photograph of the internal arrangement of the target chamber for Test # 1 without the equipment Rack Simulant and Test #5 with the equipment rack simulant. Note that the internal surfaces of the chamber were lined with 1 cm polyurethane foam panels. These panels reduced the "noise" in the over pressure readings considerably when compared to several checkout tests without the foam liners, and so were utilized through the tests reported here. Note also the presence of a square fiberboard witness panel hung from the chamber ceiling approximately 2.6 meters downrange of the point of penetration in order to characterize the mass characteristics within the debris cloud from the penetrating particle and shield target assembly.

Figure 1 Photograph of the UAH Target Chamber for the 108 mm Gun System used in this Test Series

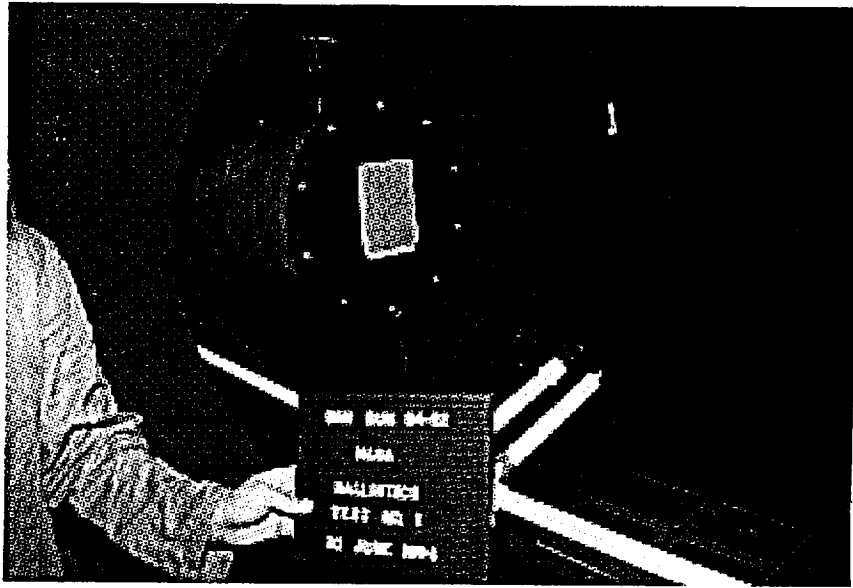
Figure 2 View of Impact Chamber Interior Without Equipment Rack Simulant

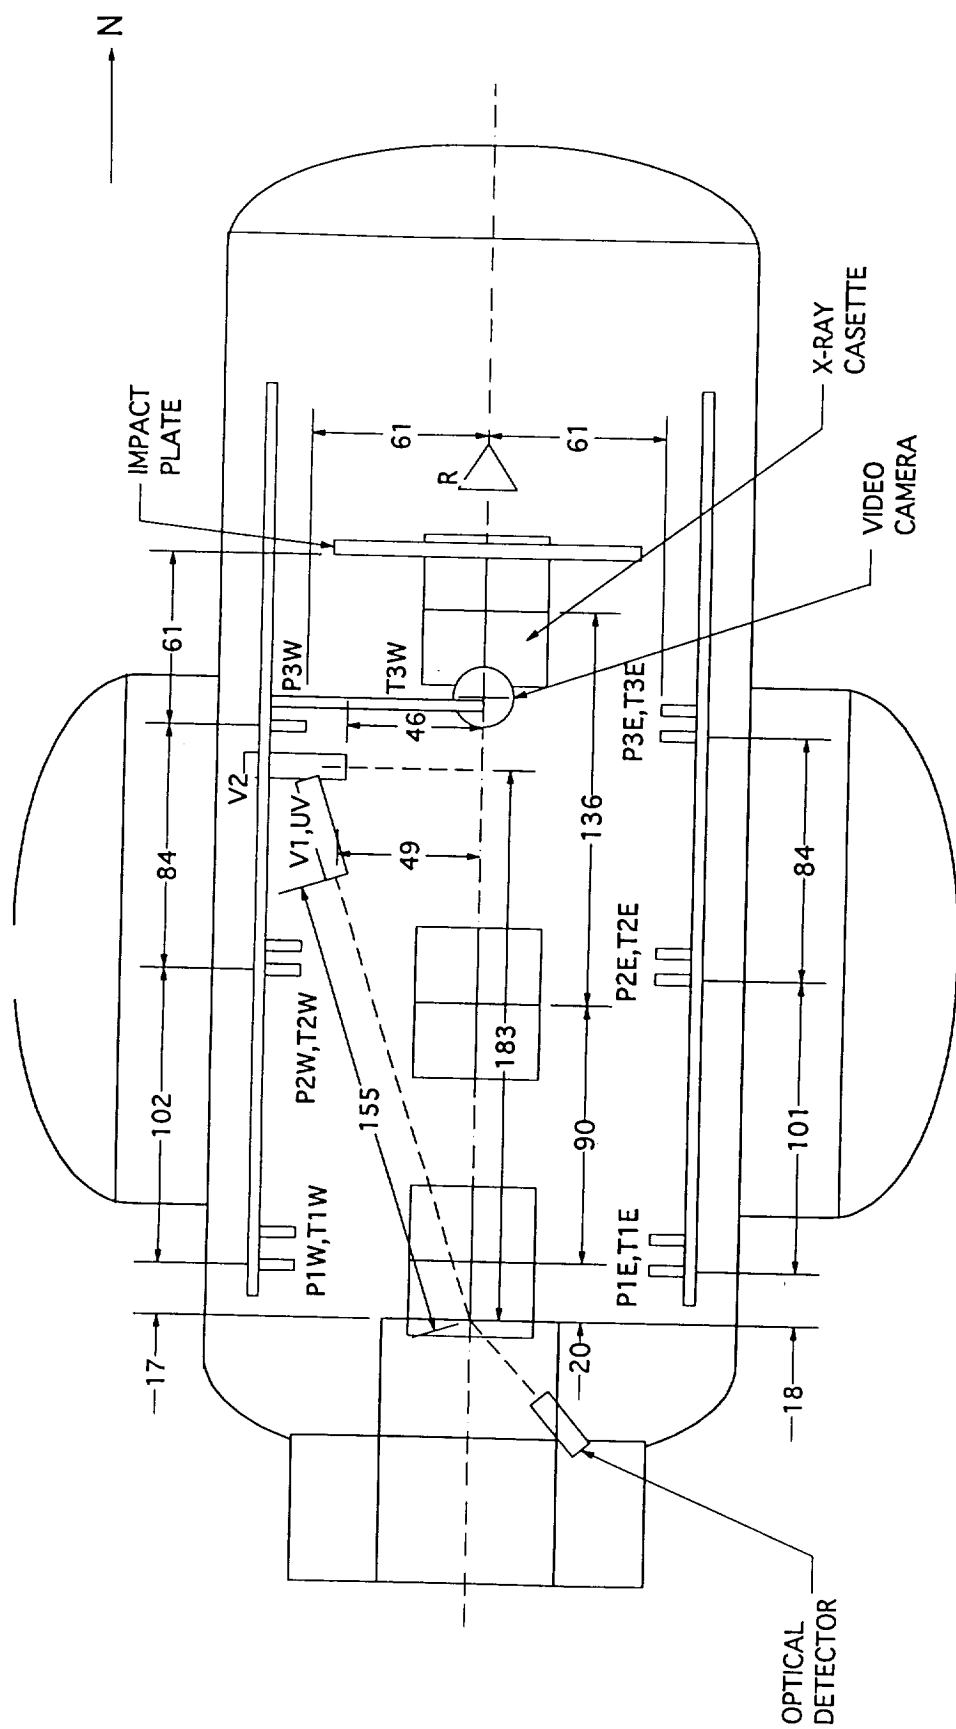
Figures 4 and 5 show cross-sectional top views of the test chamber for the cases without and with the simulated internal equipment cabinets respectively. Pressure and temperature sensors were paired in six positions within the target tank, three pairs along each side. For most tests, pressure and temperature sensors 1E and 1W were located on the east and west walls (respectively) of the tank at an approximate "line of sight" distance of 62 cm from the pressure bearing surface (pressure wall) of the shield target. Sensors 2E and 2W were approximately 136 cm from the pressure wall of the shield target; sensors 3E and 3W were approximately 253 cm from the target pressure wall. Notable exceptions to these general sensor locations included (1) the position of temperature sensor 3W, which was lengthened subsequent to Test 1 to measure the temperature directly along the centerline of the test chamber, and (2) the position of temperature and pressure sensors 1W in Tests 10 and 13, which were also extended to measure the over pressure inside an equipment rack mockup very near the point of penetration (see Figure 2). A low speed video camera (30 frames/sec) was trained at the target plate through a Plexiglas window and mirror arrangement at the roof of the target chamber.

Figure 4 Cross Sectional Top Down View of Test Chamber Without Equipment Rack Simulant

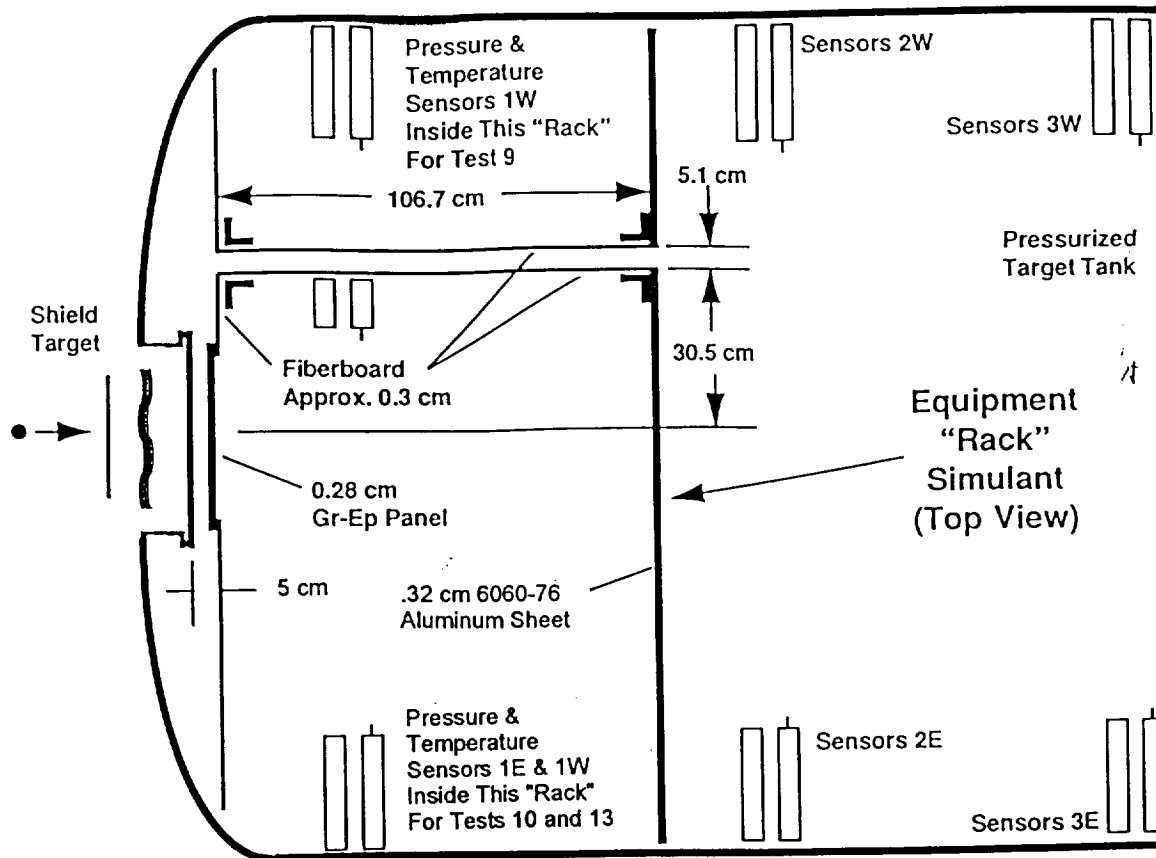
Figure 5 Cross Sectional Top Down View of Test Chamber With Equipment Rack Simulant

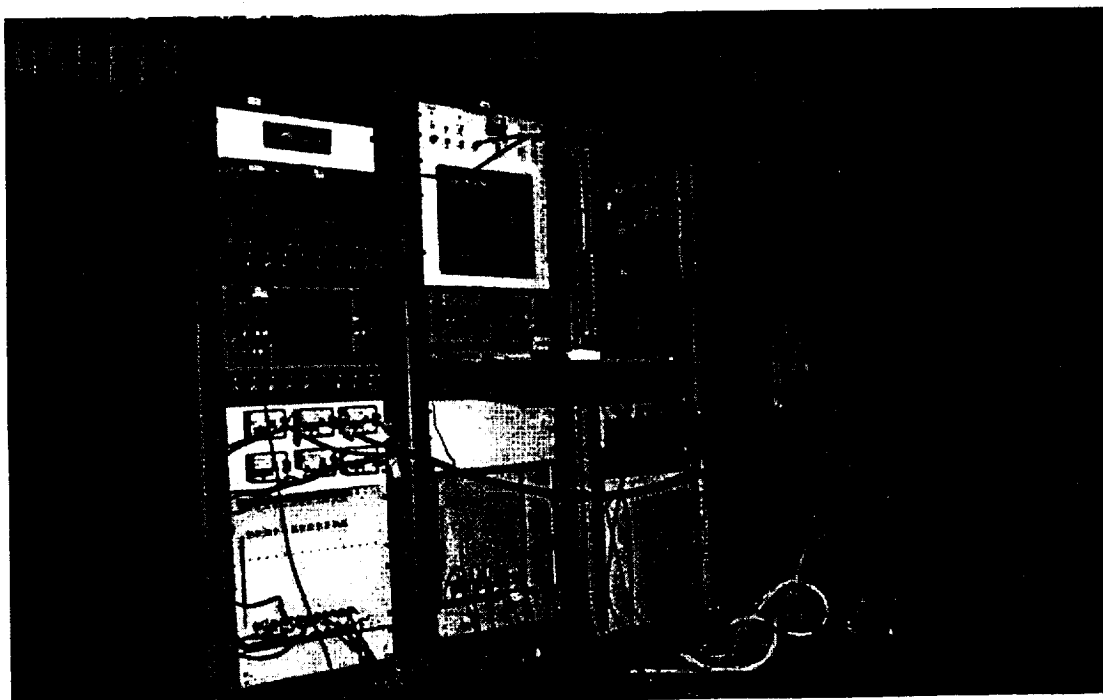
Figure 6 Photograph of Digital Acquisition System

Data acquired by the various sensors were recorded on a Nicolet Digital Data Acquisition system which has a maximum sampling rate of 10 MSamples/s, 12 bit resolution and 1 Mbyte memory per channel. The actual sampling rate was adjusted depending on the expected data recording time. The instrumentation rack which contains the data acquisition system is shown in Figure 6.

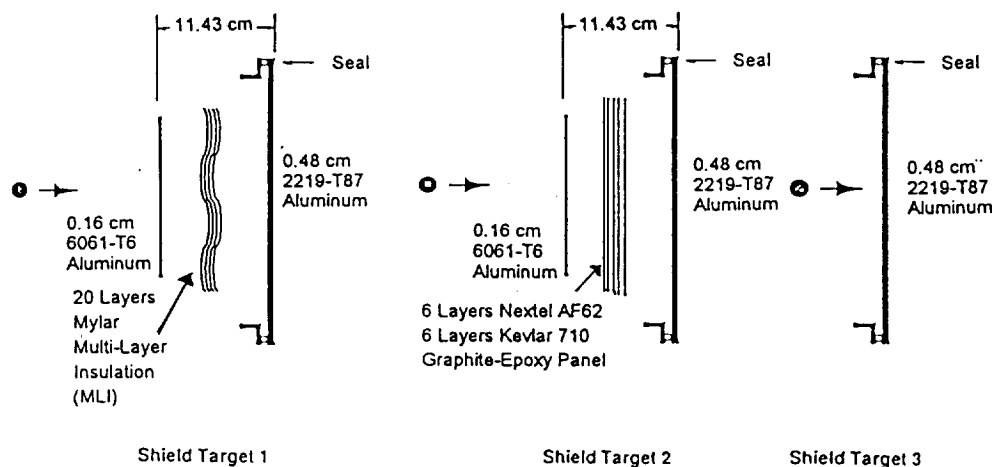
Figure 7 shows a sketch of the three types of spacecraft shield targets that were featured in this test series. Shield target 1 is essentially a simple two-wall bumper shield, with the second wall acting as the pressure bearing surface of the spacecraft. The ballistic limit (size of aluminum sphere that will marginally penetrate this type of target) for shield target 1 is approximately 1.0 cm (at 6.5 km/sec). Shield target 2 is an enhanced orbital debris shield that features intermediate layers of Nextel, Kevlar, and graphite between the outer bumper and rear pressure wall. These layers increase the ballistic limit of this shield package to approximately 1.35 cm (at 6.5 km/sec). Shield target 3 is a simple single pressure wall with no bumpers. The ballistic limit of this target is very low, requiring only a 0.1 cm spherical aluminum particle to penetrate this shield target.

Figure 7 Sketch of Three Space Craft Shield Targets

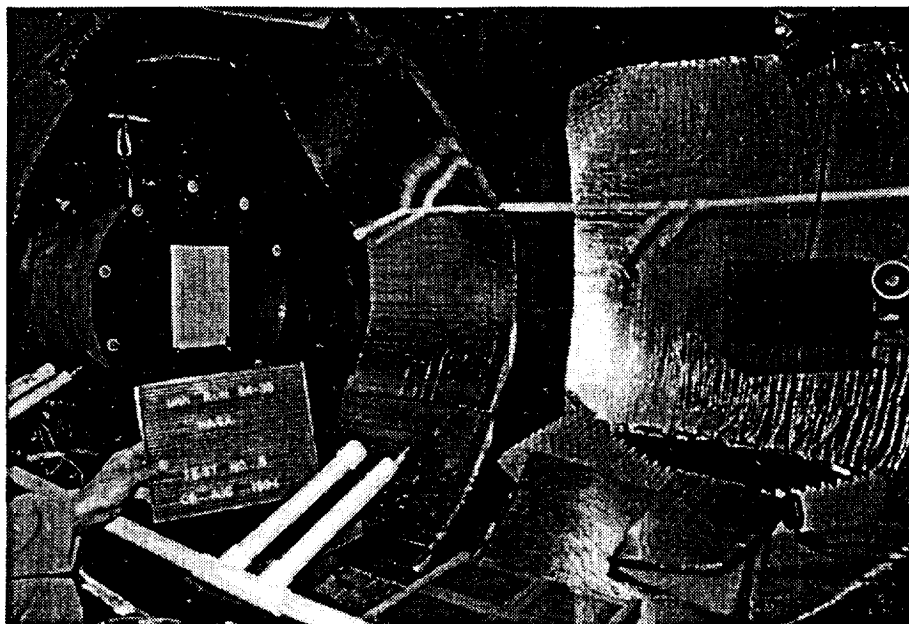
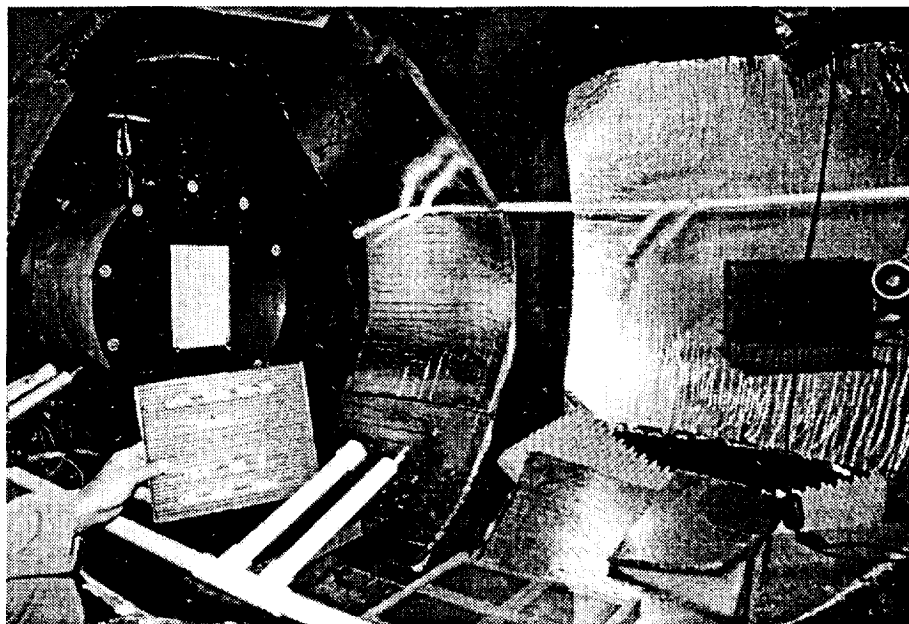
Figure 8 shows photographs of the internal arrangement of the target chamber for Test 5. Note that the internal surfaces of the chamber were lined with 1 cm thick polyurethane acoustic attenuating foam panels. These panels reduced the "noise" in the over pressure readings considerably compared to several checkout shots without the foam liners, and so were utilized through the tests reported here. Note also the presence of a square fiberboard witness plate hung from the chamber ceiling approximately 2.6 meters downrange the point of penetration in order to determine the mass characteristics within the debris cloud from the penetrating particle and shield assembly.

Figure 8a Photograph of Target Chamber for Test 5 - View Towards Shield Target

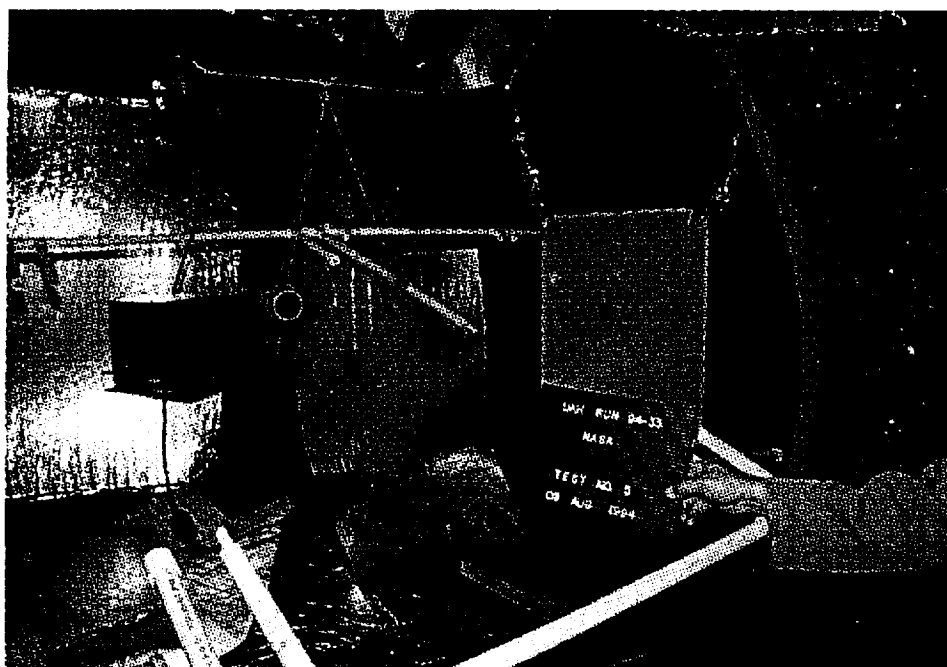
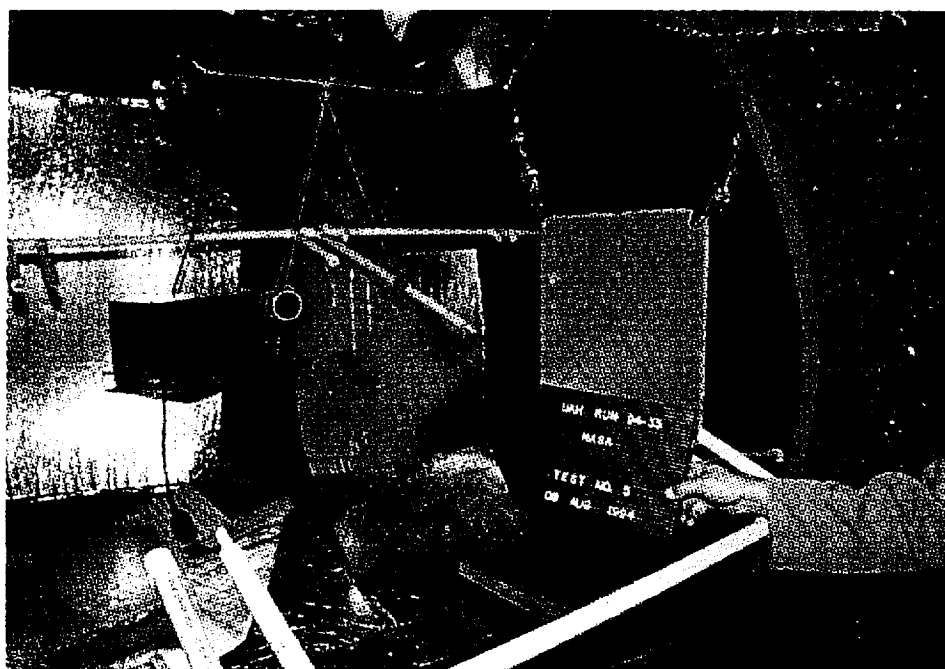
Figure 8b Photograph of Target Chamber for Test 5 - View Away from Shield Target (Downrange)

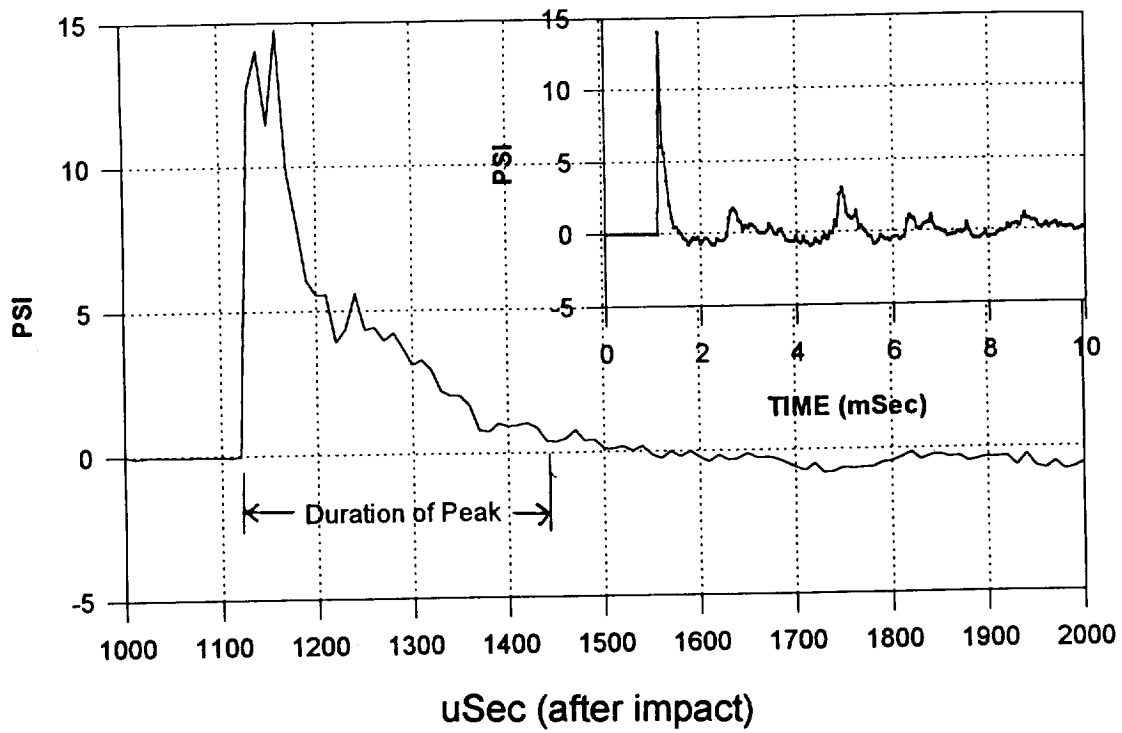
Figure 9 Typical Over Pressure Profiles from Sensor Position 1 (No Internal Equipment Simulant)

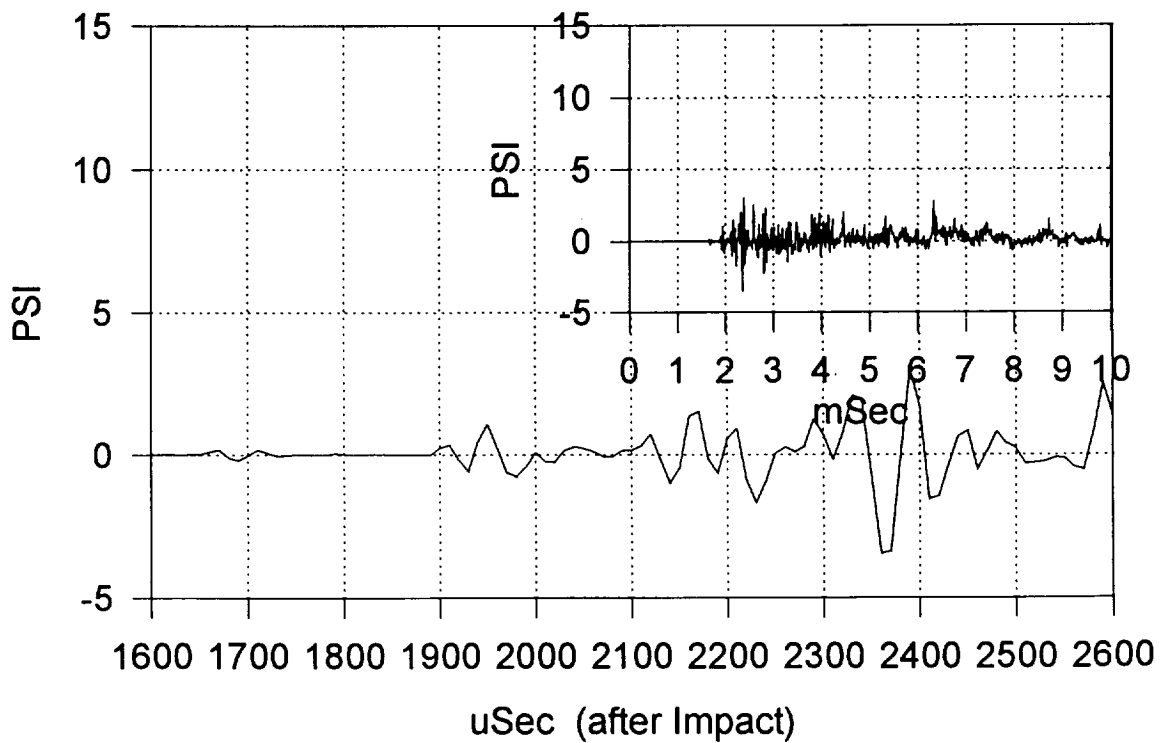
Figure 10 Typical Over Pressure Profiles from Sensor Position 3 (No Internal Equipment Simulant)

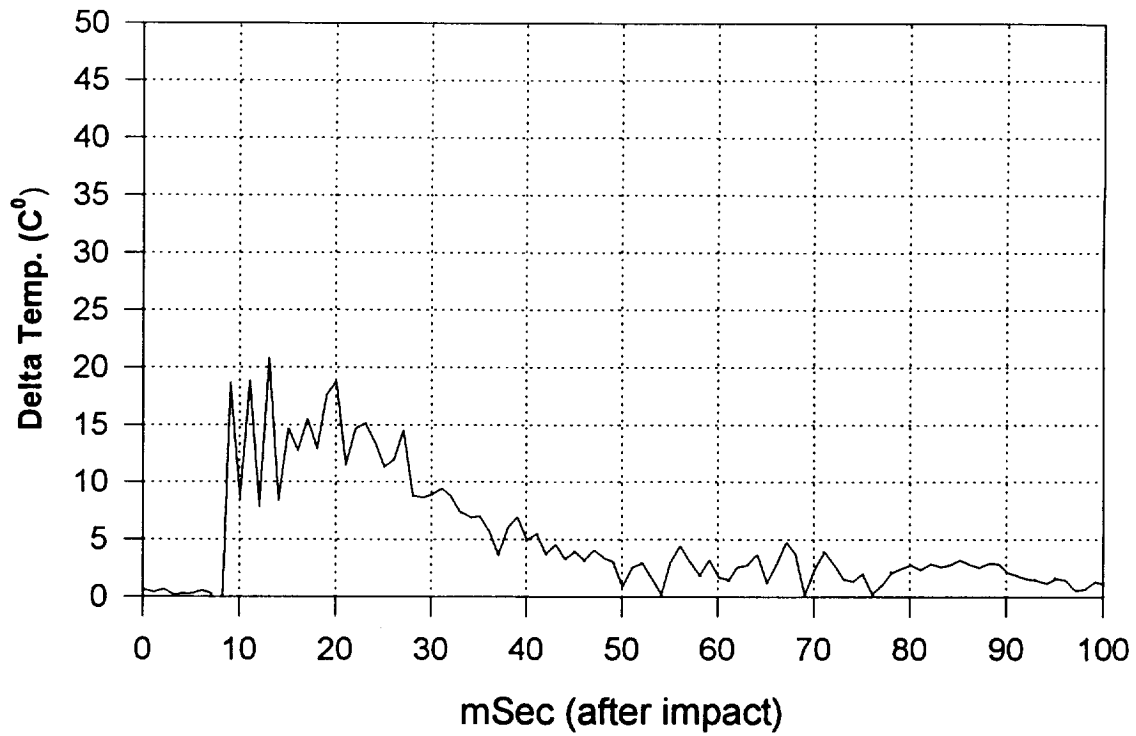
Figure 11 Typical Temperature Profiles from Sensor Position 1 (No Internal Equipment Simulant)

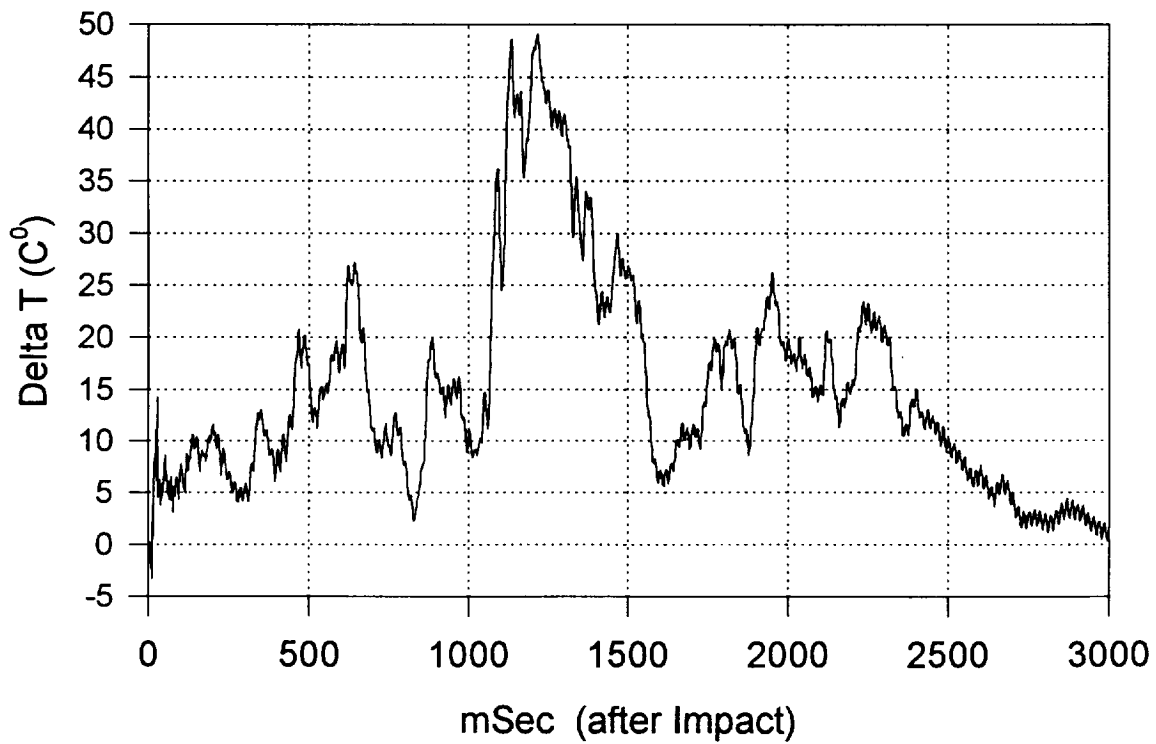
Figure 12 Typical Temperature Profiles from Sensor Position 3 (No Internal Equipment Simulant)

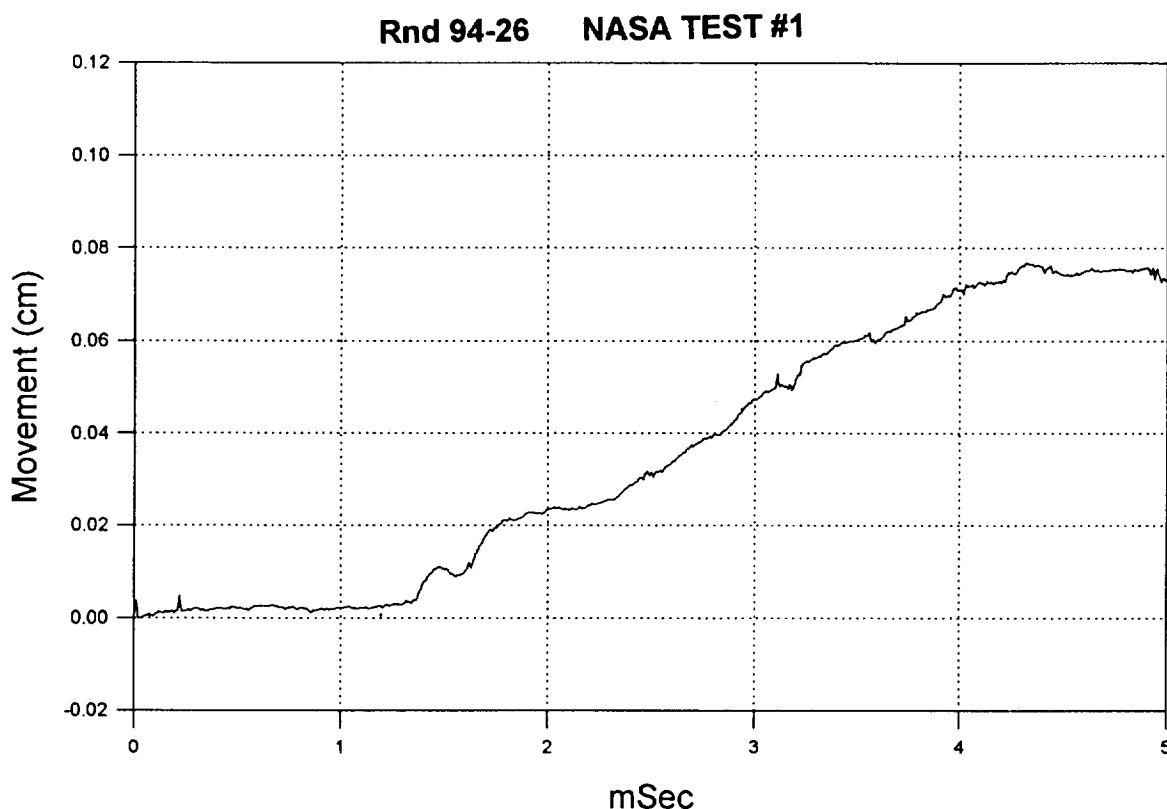
In order to obtain a measure of the residual energy in the debris cloud from the penetration of the target plate, a 17 GHz Doppler radar was installed to view the motion of the witness plate during the tests. This data is presented in Figure 13.

Figure 13 Doppler Radar data on Witness Plate Motion

approximately 40 grams (also true for all tests of shield type 2). Despite this large amount of initial mass in the debris cloud, the one meter square fiberboard witness panel (weighing 2700 gms) located at 2.7 meters from the impact point was relatively undamaged, with one small (< 0.1 gram) particle imbedded within it. This lack of mass in the witness panel was curious, and consistent throughout the tests of all target types. This observation is supported by the Doppler radar measurement of the witness plate motion. The projectile mass was 3.0 gms and actual velocity was 6.69 km/s, resulting in projectile momentum of 2×10^6 gm-cm /s. The witness plate mass was 2702 gms and measured velocity was 20 cm/s, resulting in momentum of 67,550 gm-cm/s. The target momentum measurement presented in Figure 13 shows very low ($\sim 3.3\%$ of the projectile momentum) momentum transfer to the witness plate.

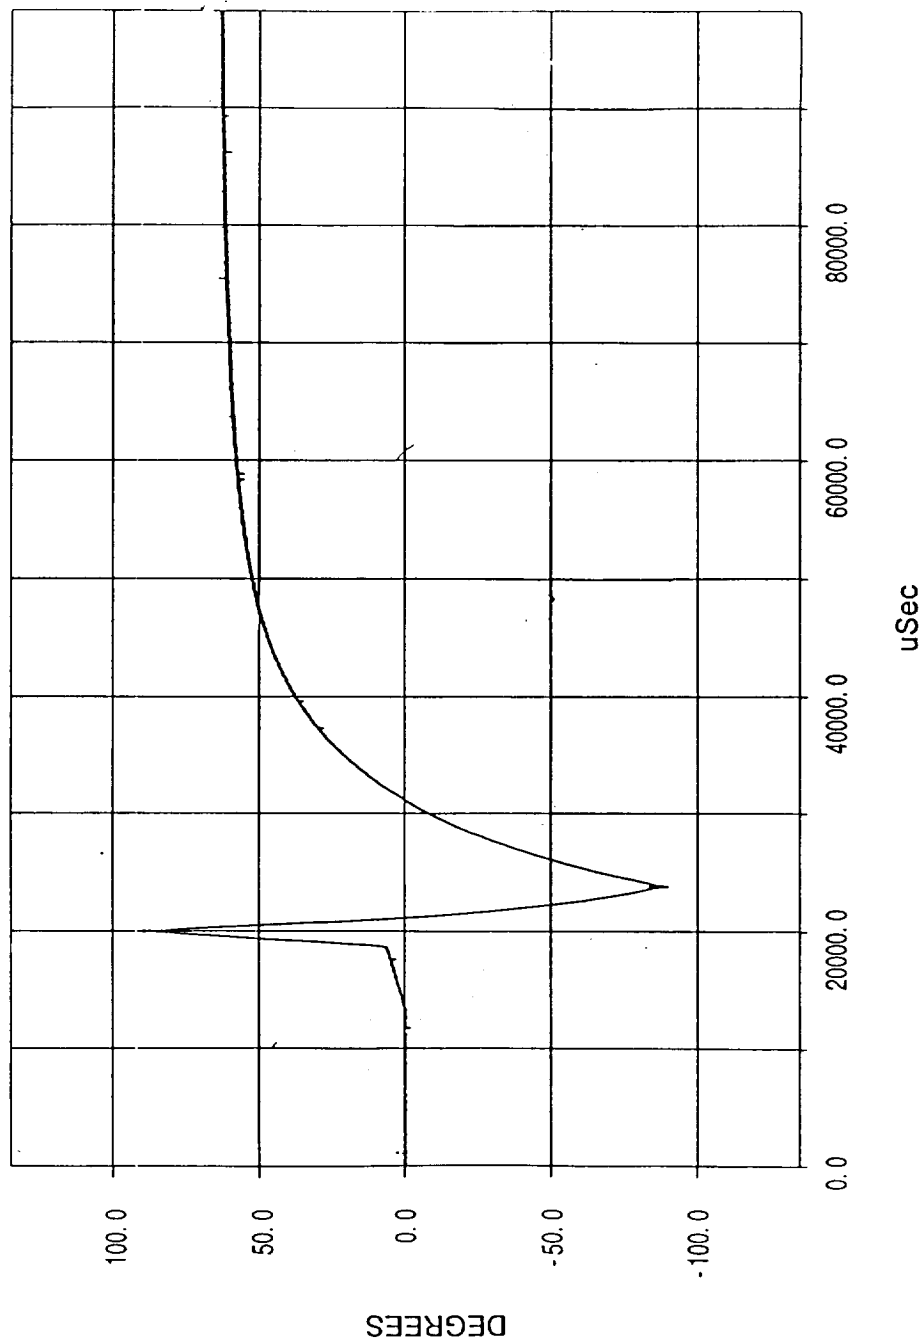
Pressure Plate Movement with Atmospheric Change

17 ghz Radar

@ Time=0 Chamber at atmosphere

@ Time=80000 uSec Chamber at 10 tor

360 Degrees = .345 inches

Figure A39 Pressure Plate Movement

The deflection of the pressure hull plate was measured using a Doppler radar operating at 17 GHz in an interferometric mode as the uprange side was pumped down to < 0.01 Torr with atmospheric pressure in the test chamber. This plate deflection data is shown in A39 of Appendix A

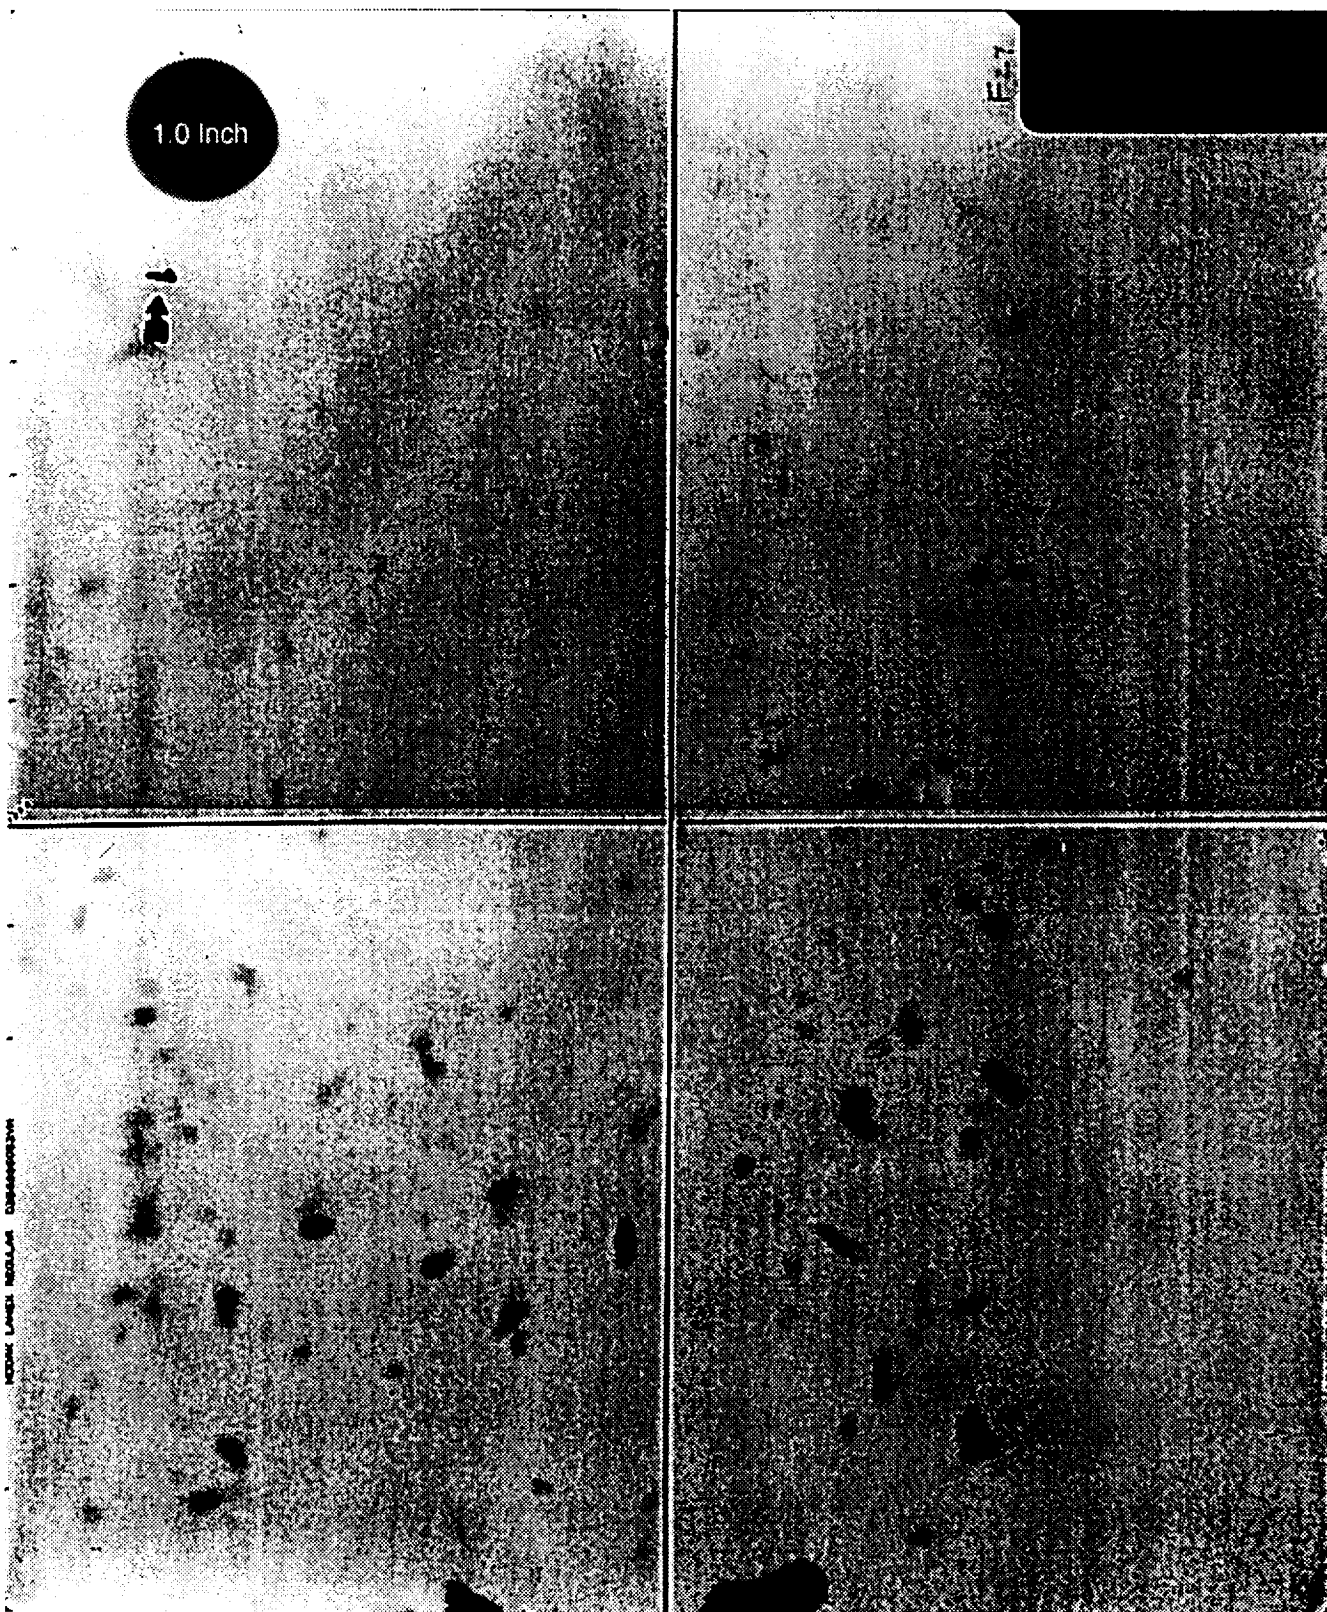
Flash X-Ray of Debris Cloud: UAH 94-26: Print One

Figure B2 X-Ray Photograph of Debris Cloud, Test # 01 X-Ray #1

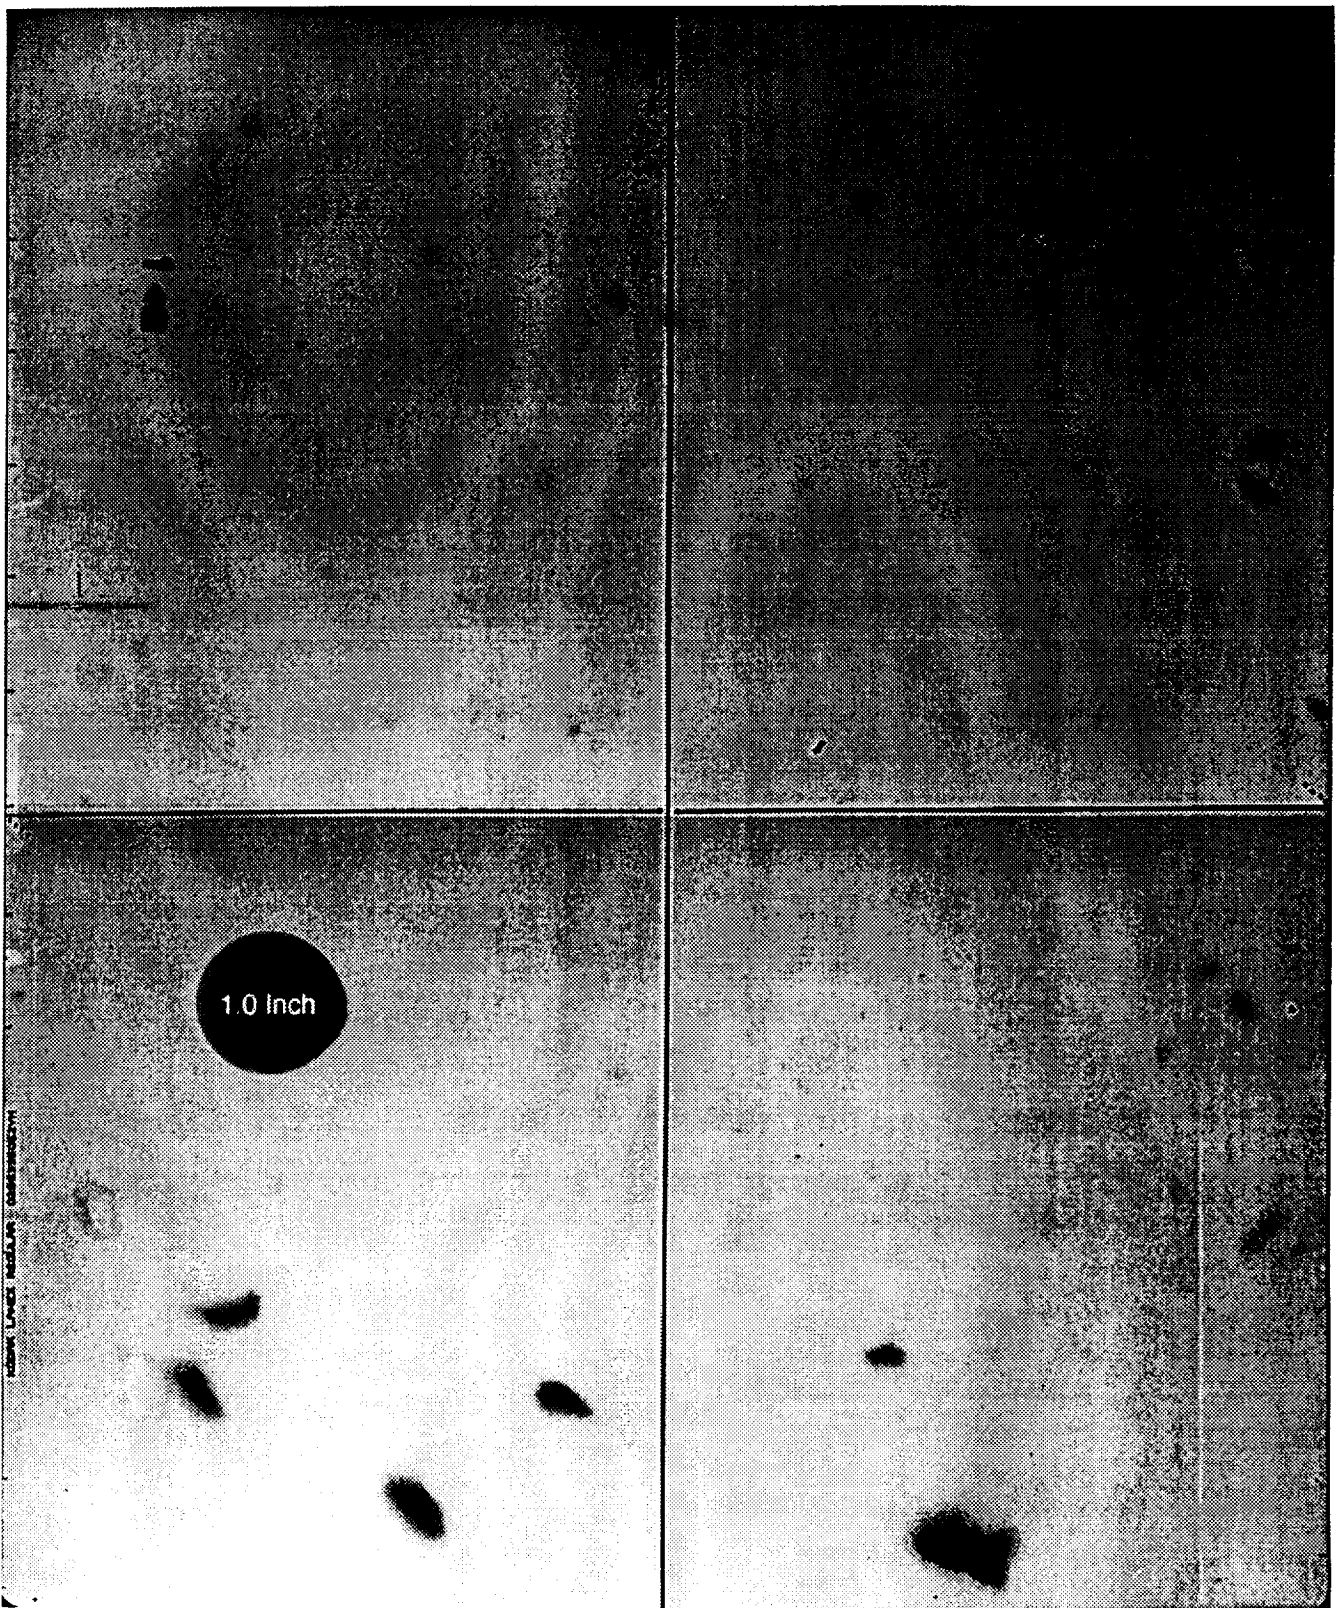
Figure B5

Flash X-Ray of Debris Cloud: UAH 94-33

X-Ray Photograph of Debris Cloud, Test # 05 X-Ray #1

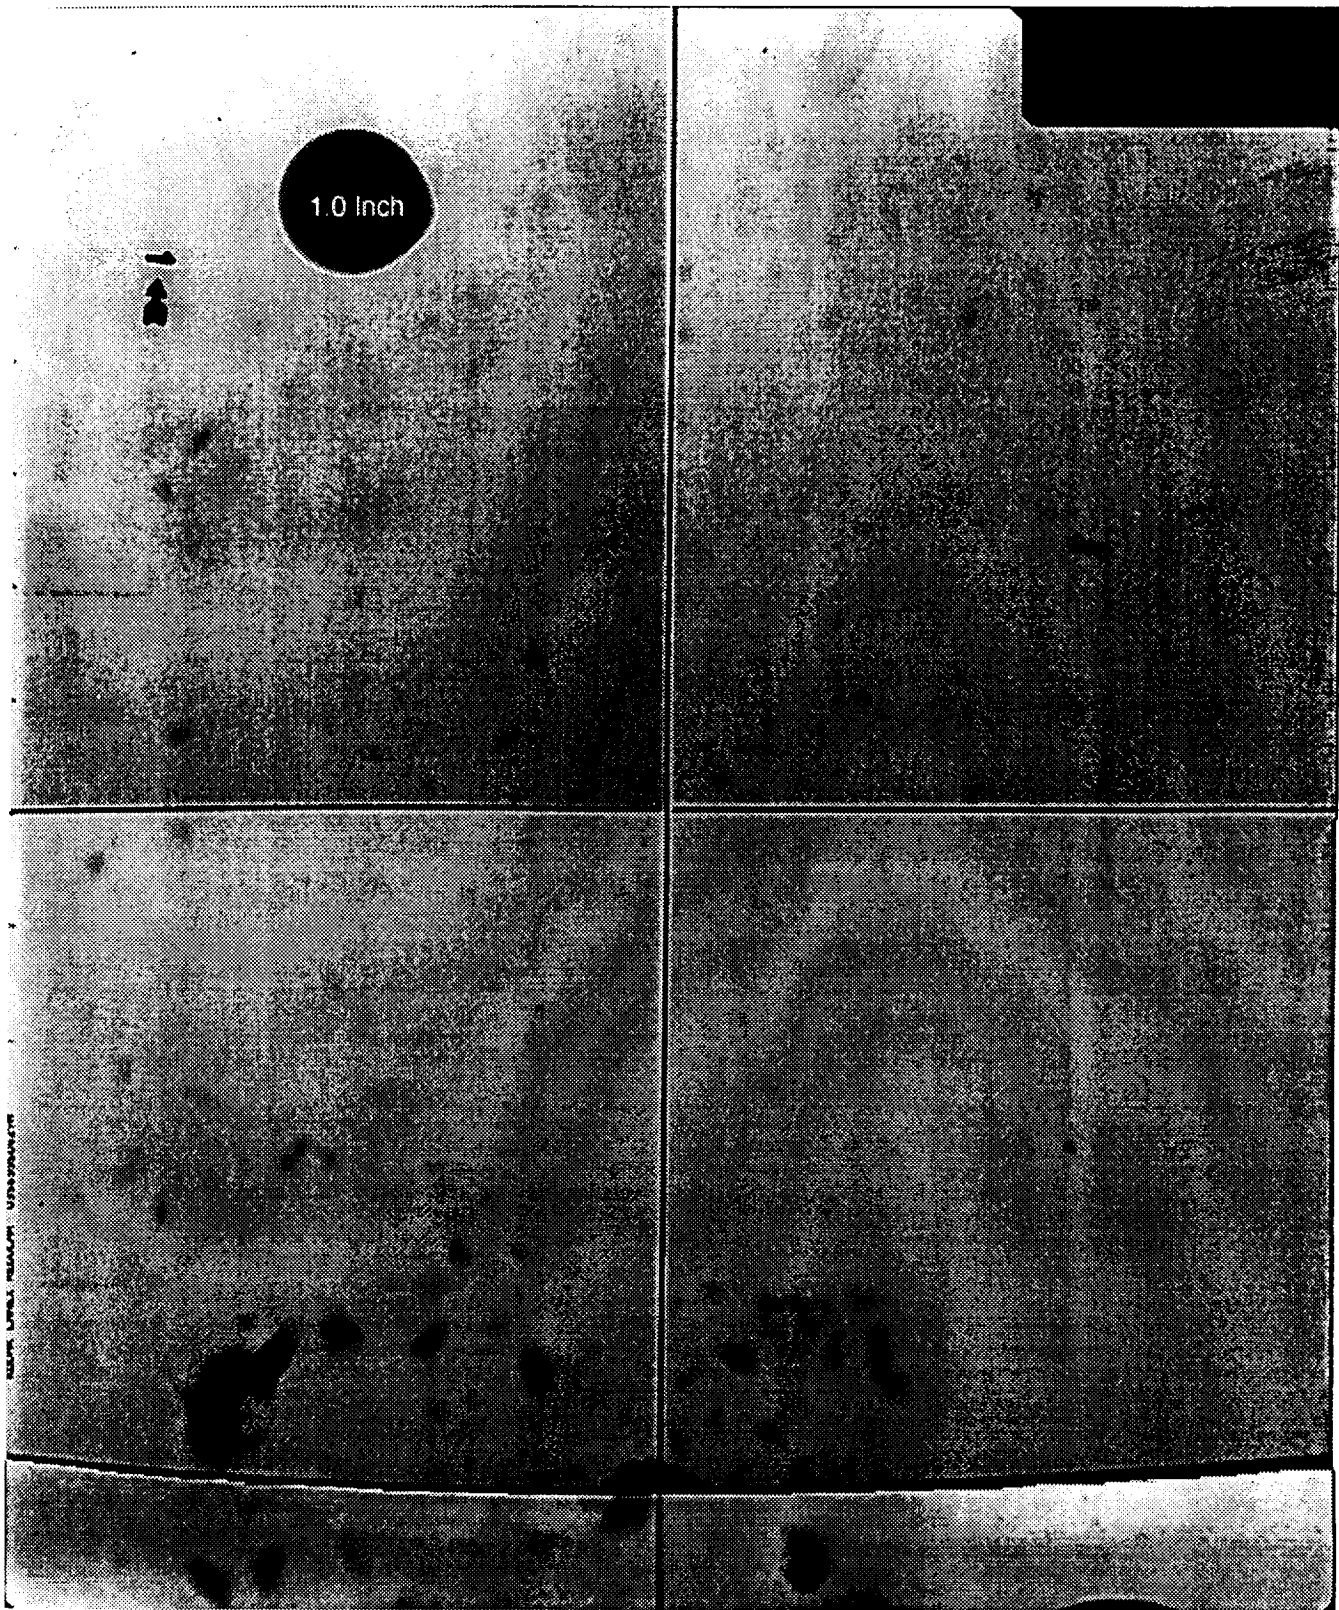
Figure B8

Flash X-Ray of Debris Cloud: UAH 94-57

X-Ray Photograph of Debris Cloud, Test # 10 X-Ray #1
